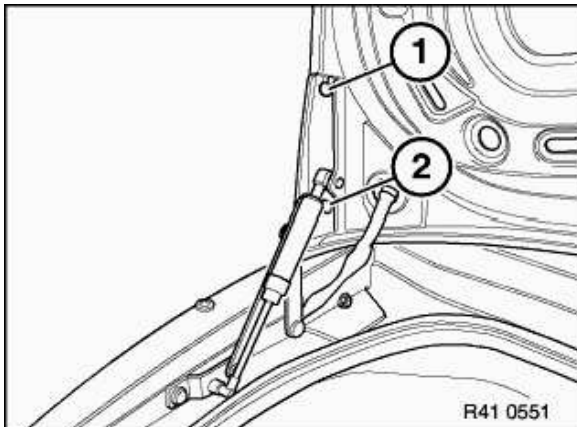
Loosen left and right bolts (1).

Unscrew left and right bolts (2).

Remove trunk lid.

Disconnect gas pressure props.

Caution!

Gas pressure props have strong tension.
